MEMORANDUM

Re: TCRA Armored Cap - Response to Request Regarding Dive Team Summary Report for April 3-9, 2016

**San Jacinto Waste Pits
Channelview, TX
April 3 – 9, 2016**

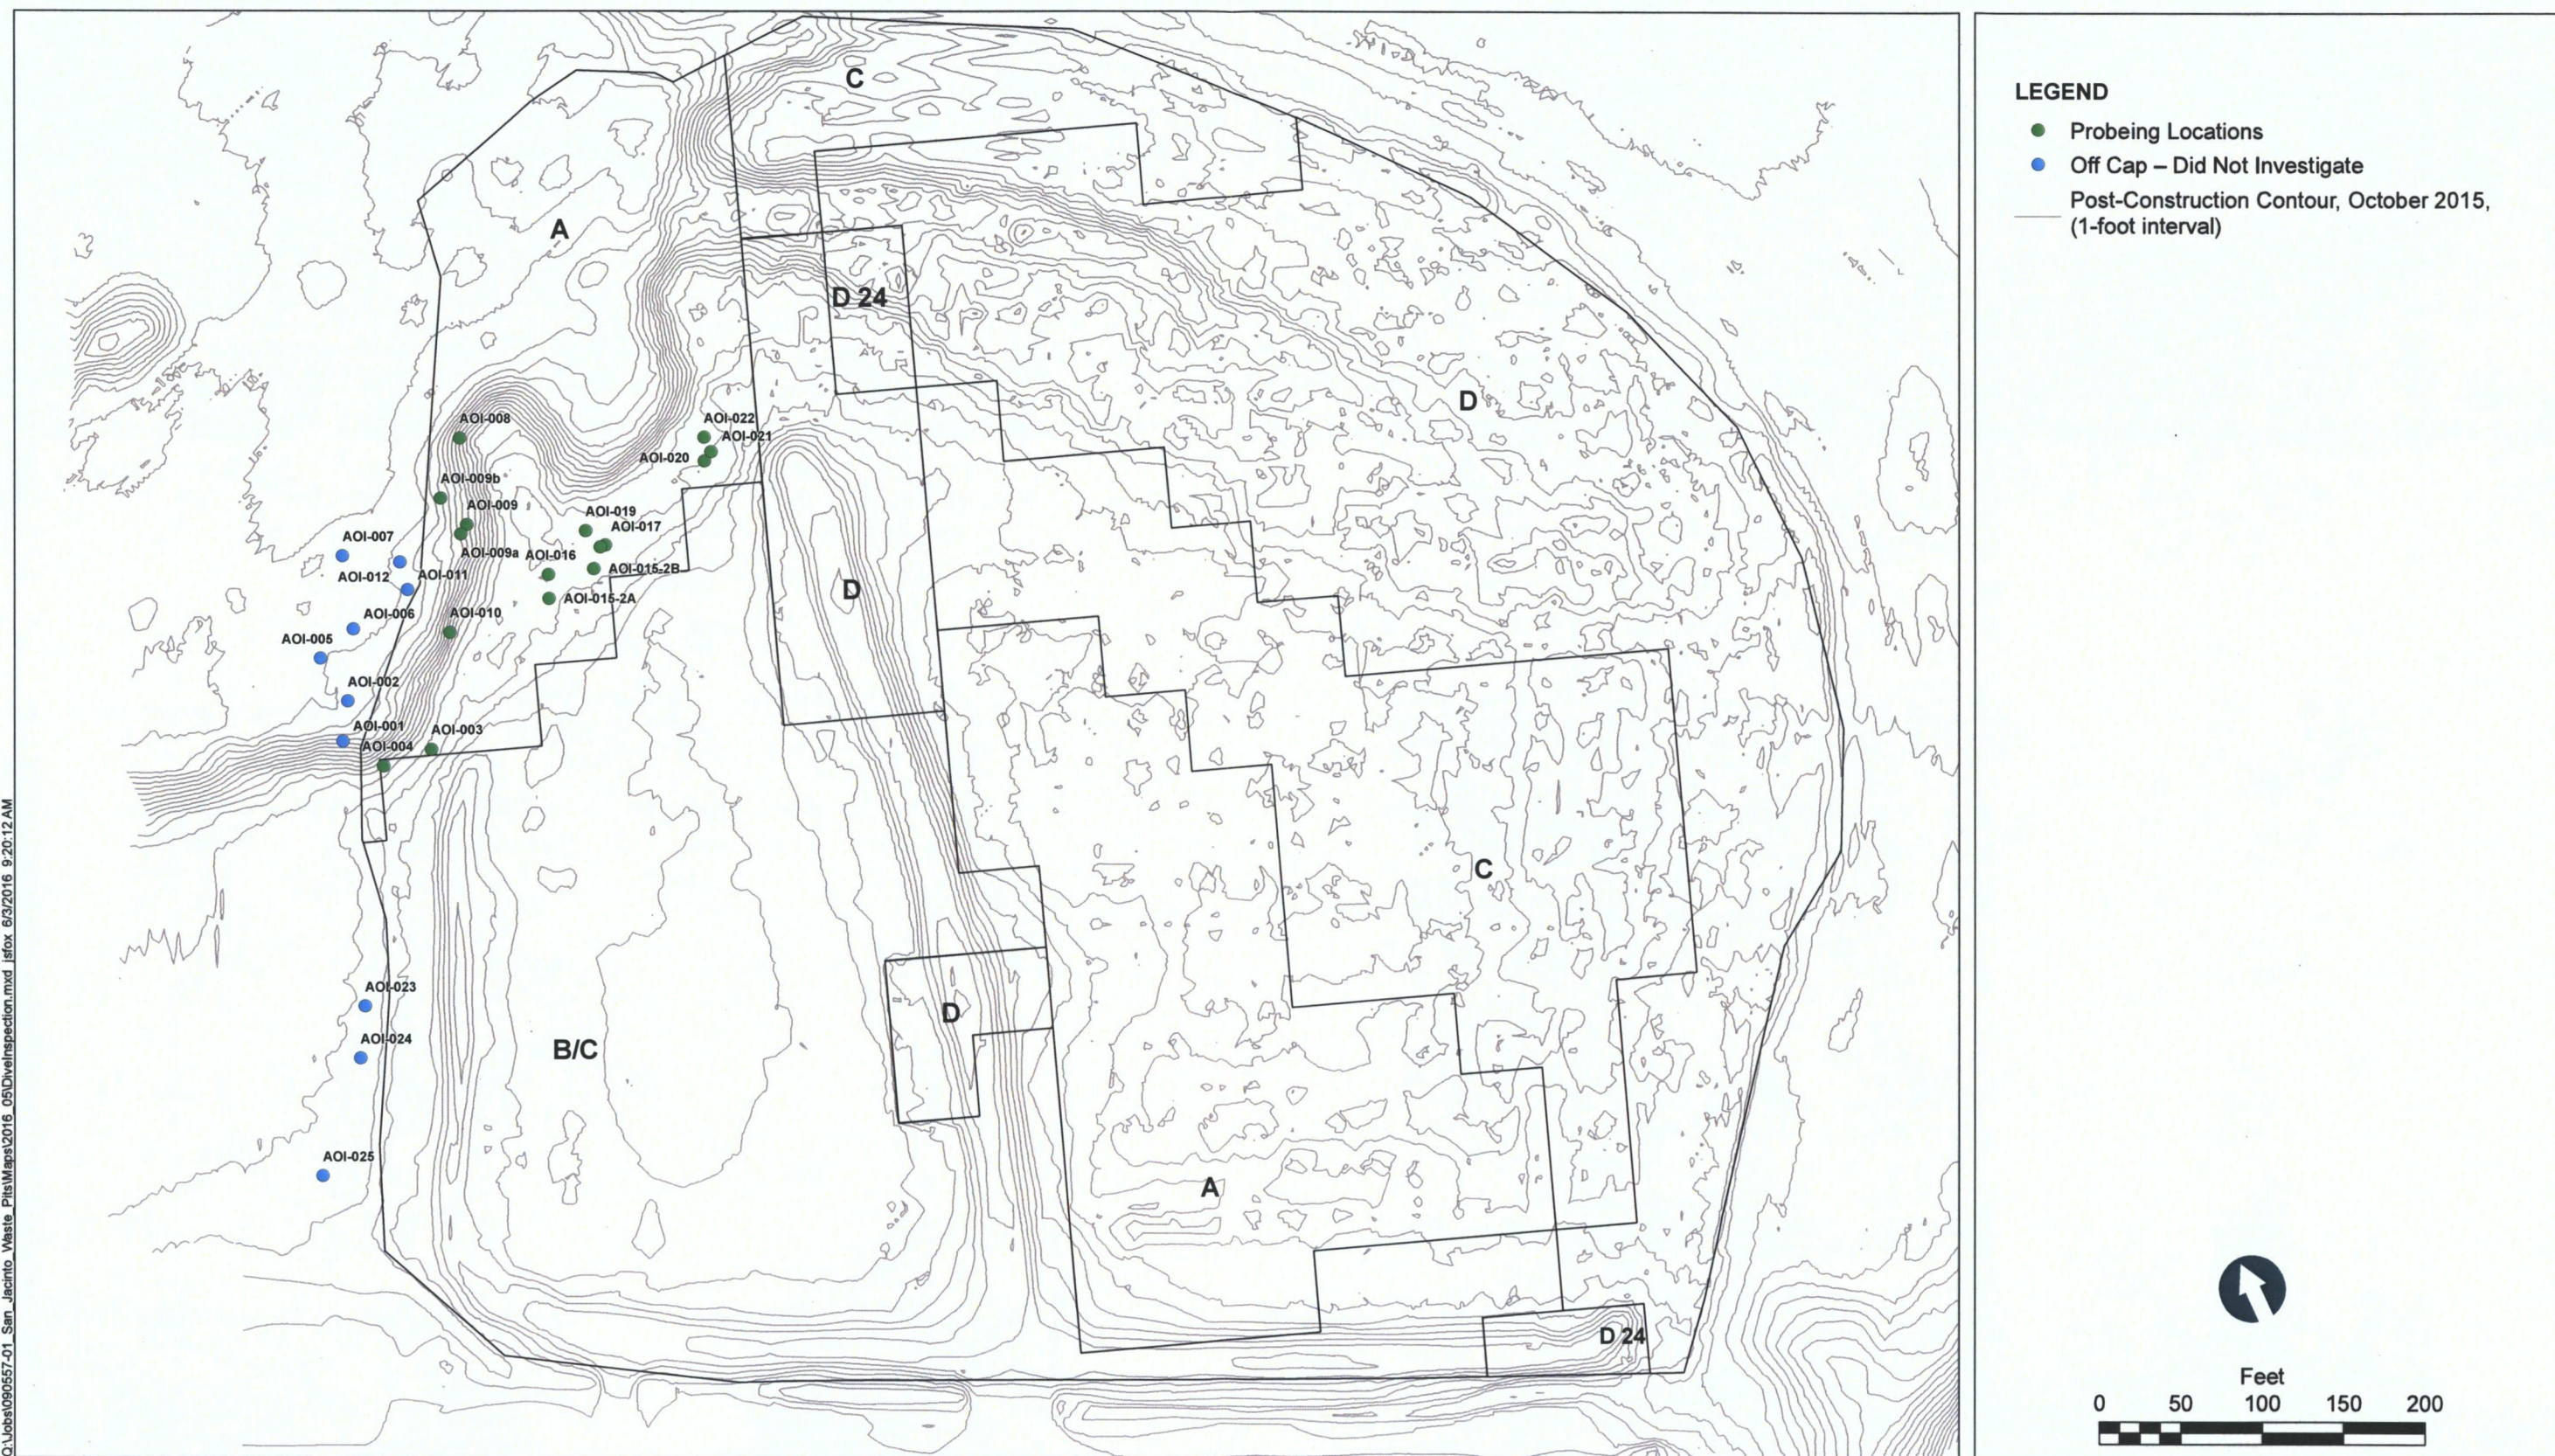
Figure 1
AOIs Identified during USEPA Dive Inspection
San Jacinto River Waste Pits Superfund Site

The AOIs, located within the Western Cell of the TCRA Armored Cap (Figure 1), were first reported to Anchor QEA field personnel who were supporting the Dive Team members on April 4, 5, 6, and 7, 2016, as they were identified. During the Dive Team Inspection, the Dive Team provided coordinates of the AOIs to the Anchor QEA support personnel that are consistent with the locations identified in the Dive Team Summary Report.

At each AOI, Mr. Mears was able to verify that armored cap material was present at the specified thickness. At AOI-8, 9, 9a, 9b, and 10, 1 to 2 feet of sediments were present above the underlying armored cap material. These results, as described in Table 1, were shared with the Dive Team. A member of the Dive Team indicated that they did not find any armored cap materials at any of these AOIs.

All AOIs identified by the Dive Team, except those identified as falling outside the boundaries of the original 1966 impoundment perimeter (as shown on Figure 1), were probed at the coordinates provided by the Dive Team and up to 5 feet away in all principal directions (north, south, east, and west) with the intent of identifying cap material presence and thickness. The AOIs were accessed by wading, and by vessel. A ½ inch × 10 foot steel rebar, a 1 inch × 10 foot plastic pipe, and three pieces of 2 inch × 12 foot aluminum pipe were utilized as probes to characterize each of the AOIs.

The findings in the Dive Team Summary Report are not supported by the results of the three days of inspections performed by Anchor QEA. As such, there is no basis for the submission of a work plan to perform maintenance in any of the AOIs identified in the Dive Team Summary Report. Respondents instead propose that representatives of Respondents and USEPA conduct a joint probing inspection of the AOIs identified in the Dive Team Summary Report. This will provide a basis to confirm conditions in each AOI and to determine if maintenance is required in any location. Should any maintenance be required, it could then be performed immediately following the joint probing inspection, using locally stockpiled materials and procedures that were implemented for purposes of recent maintenance events.

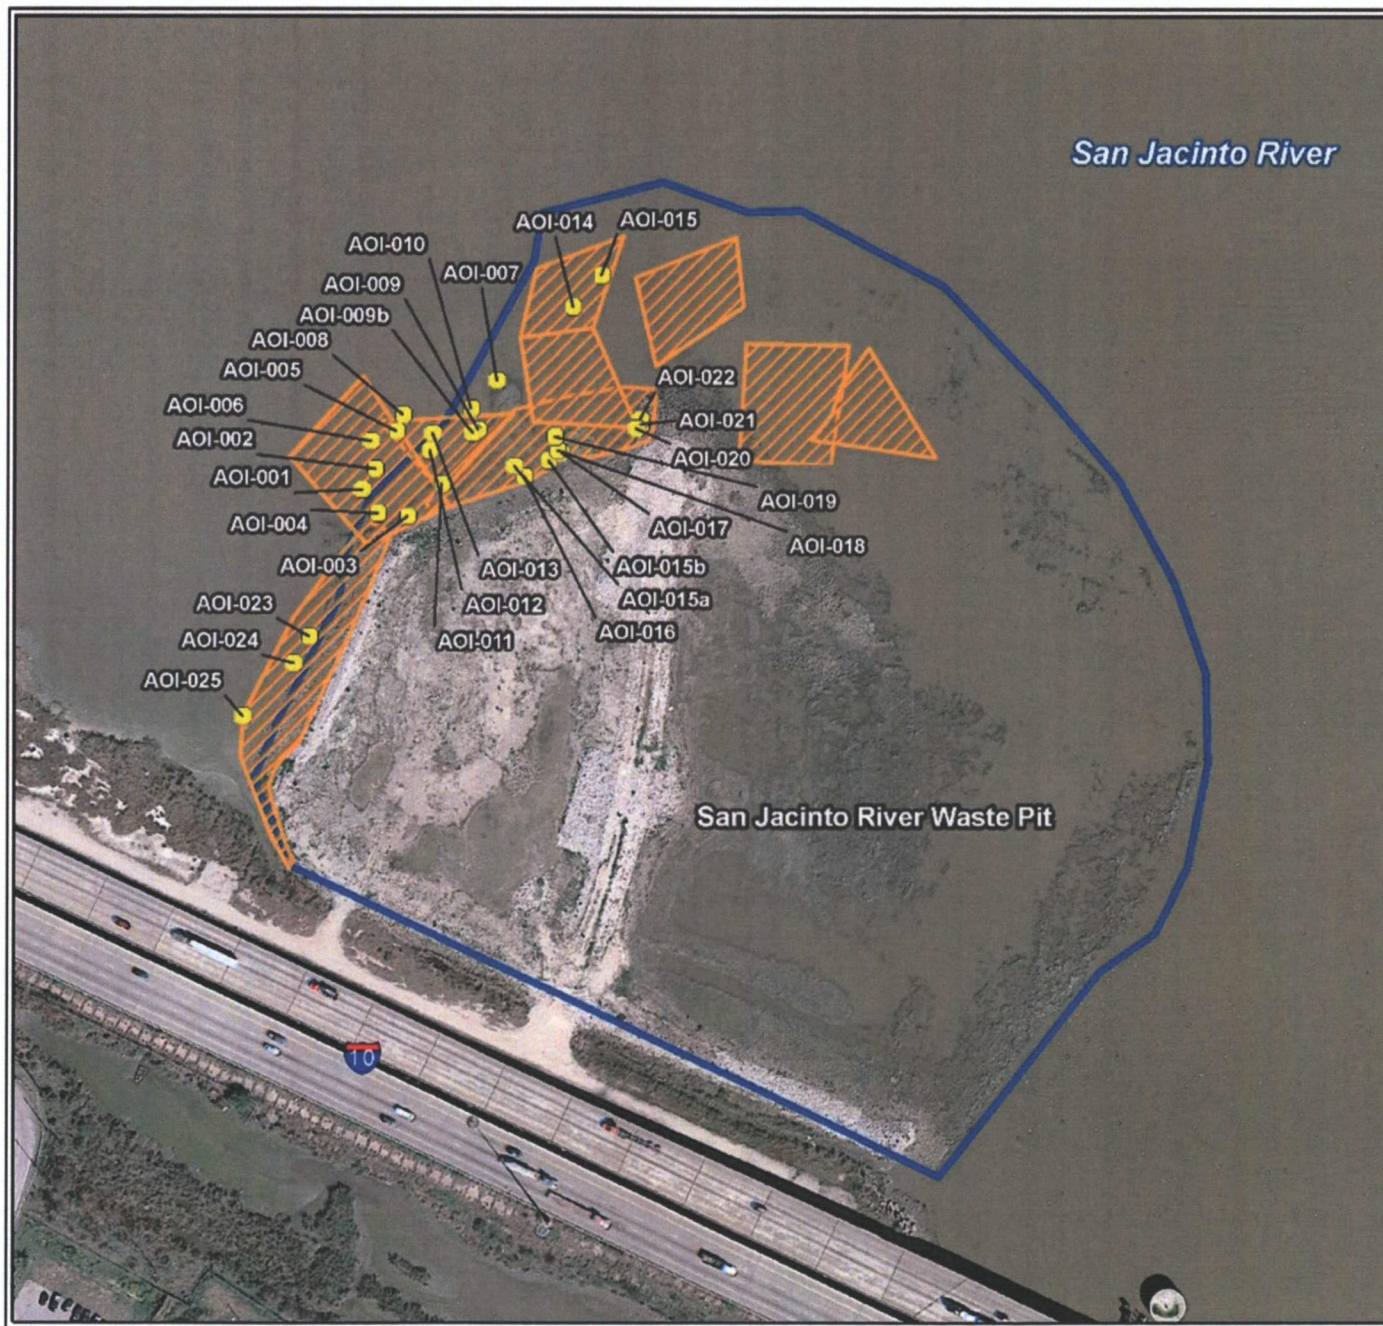
San Jacinto River Waste Pit
EPA Dive Team Survey, 4/2016
Harris County, TX

GPS coordinate ID	description of rock present	approx. surface dimensions	max detectable depth*	probing method	observations
AOI-001	no rock	5x5'	4-4.5'	diving	top 1.5' is very thick sediment. Outside of cap boundary based on attached map.
AOI-002	no rock	10' long or greater	4-4.5'	diving	Outside of cap boundary based on attached map.
AOI-003	sparse rock	not determined	5-6'	wading	
AOI-004	no rock	not determined due to depth of water	4-5'	wading	
AOI-005	sparse rock	15' long	4-5'	diving	2' thick sediment over gravel over sparse rock. GPS mark may not be not accrate. Outside cap boundary based on attached map.
AOI-006	no rock	20x20'	4-5'	diving	2' very thick sediment over gravel. Outside cap boundary based on attached map.
AOI-007	some gravel	3x3'	5-6'	wading	top 2-3' is thick sediment mixed with gravel. Not a full 12" of gravel. Grey sludge underneath loose gravel.
AOI-008	no rock	6-10' diameter	4-4.5'	diving	very thick/muddy sediment. Not flocculent. Outside cap boundary based on attached map.

AOI-009 & AOI-009b	sparse rock	5' wide. GPS coordinates mark lenth.	5-6'	wading	
AOI-010	no rock	3x3'	4-4.5'	diving	rock surrounding the area without rock.
AOI-011	some gravel	6x10'	5-6'	wading	sheen produced when probed.
AOI-012	sparse rock	5x5'	4-4.5'	diving	large rock surrounding the area without rock
AOI-013	no rock	6x2' possibly larger	4'	diving	
AOI-014	no rock	3x3'	greater than 5'	diving	rock surrounding the area without rock.
AOI-015	no rock	5x5'	greater than 4'	diving	possible geo membrane encountered. GPS coord may not be accurate.
AOI-015a & AOI-015b	no rock	20' long N to S. GPS coordinates mark E to W	5-6'	wading	largest area without rock
AOI-016	sparse rock	4x3'	mininum 4'	wading	
AOI-017	sparse rock	3x3'	5-6'	wading	
AOI-018	sparse rock	2x3'	5-6'	wading	
AOI-019	no rock	10x10'	5-6'	wading	
AOI-020	no rock	2x2'	greater than 6'	wading	
AOI-021	no rock		5-6'	wading	Possibly same area as AOI-020.

AOI-022	no rock	8x4'	5-6'	wading	rock surrounding the area without rock.
AOI-023	no rock		5-6'	wading	Outside cap boundary based on attached map.
AOI-024	no rock		5-6'	wading	Outside cap boundary based on attached map.
AOI-025	no rock		5-6'	wading	Outside cap boundary based on attached map.

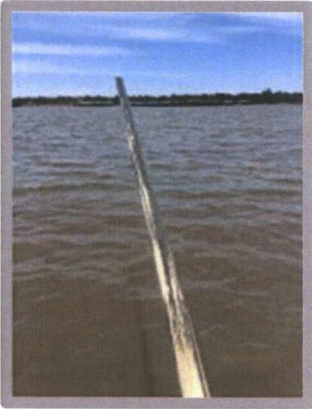
April 9, 2016

10 ft PVC pipe covered in sediment from probing between coordinates AOI-015a and AOI-015b. Sediment was very thick and gray in color.

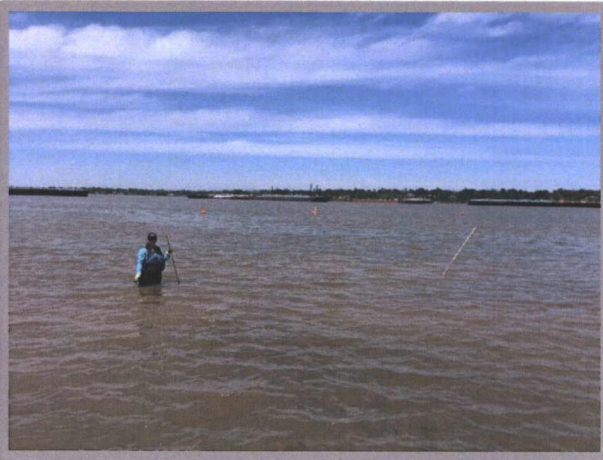
April 9, 2016

Wading activity to determine the presence or absence of rock on the Cap. EPA diver inserted rebar and PVC pipe marking coordinates of AOI-015a and AOI-015b at the outer limits of an area without rock.
